Connemara Greenway - Clifden to Oughterard

Environmental Impact Statement
Volume 2 -Appendices

Client	Galway County Council					
Project Title	Connemara Greenway Project – Clifden to Oughterard					
Document Title	Environmental Impact Statement – Volume 2 Appendices					
Document No.	MGE0269RP0003					
This Document Comprises	DCS	TOC	Text	List of Tables	List of Figures	No. of Appendices
	1	-	140	-	-	4

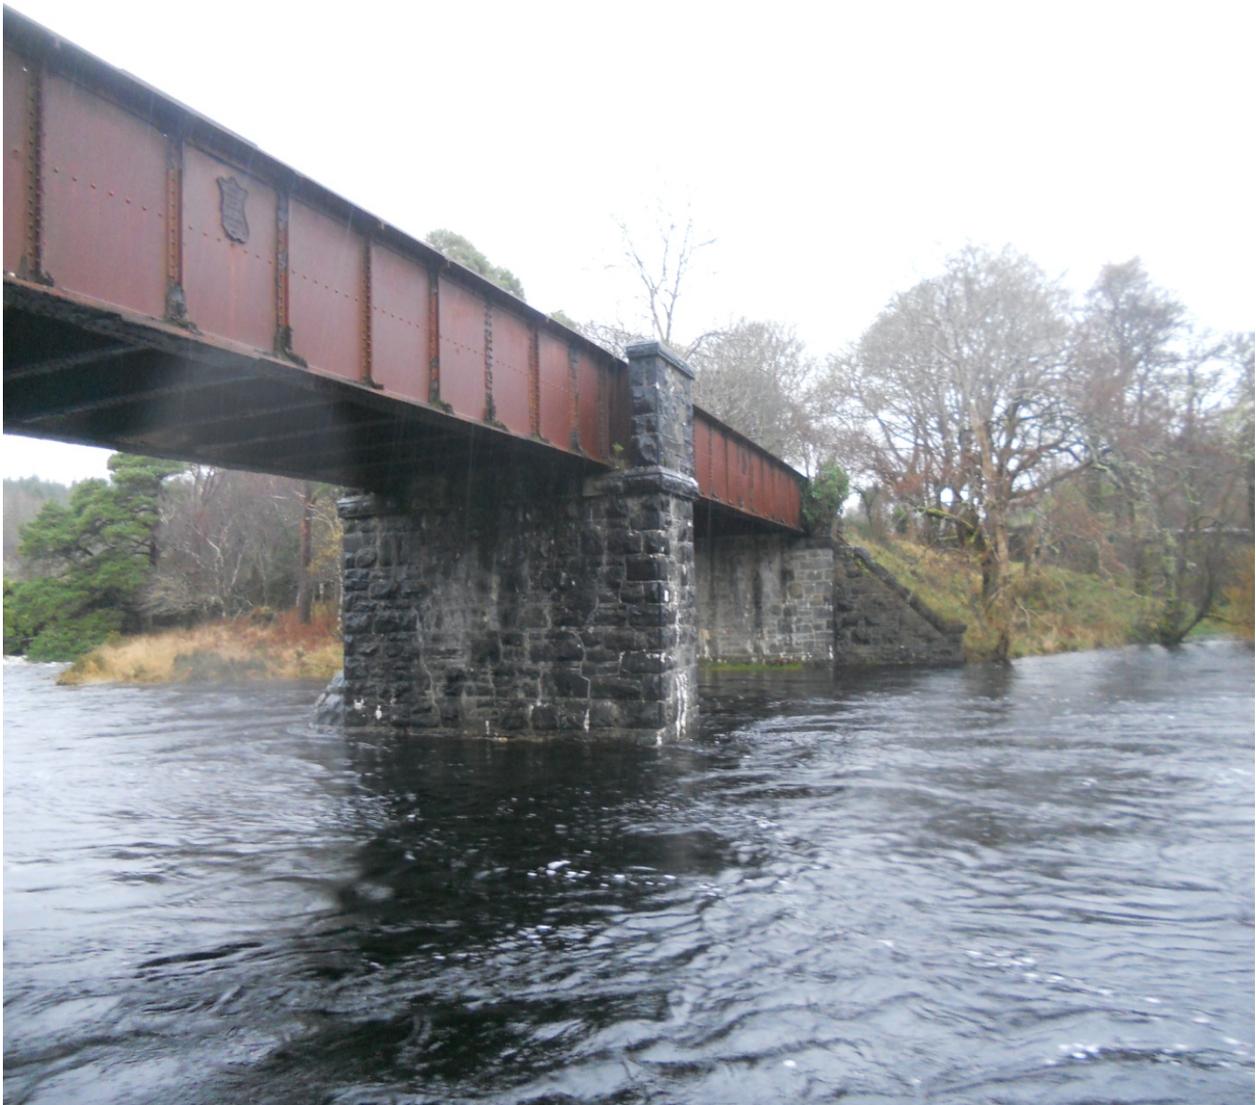
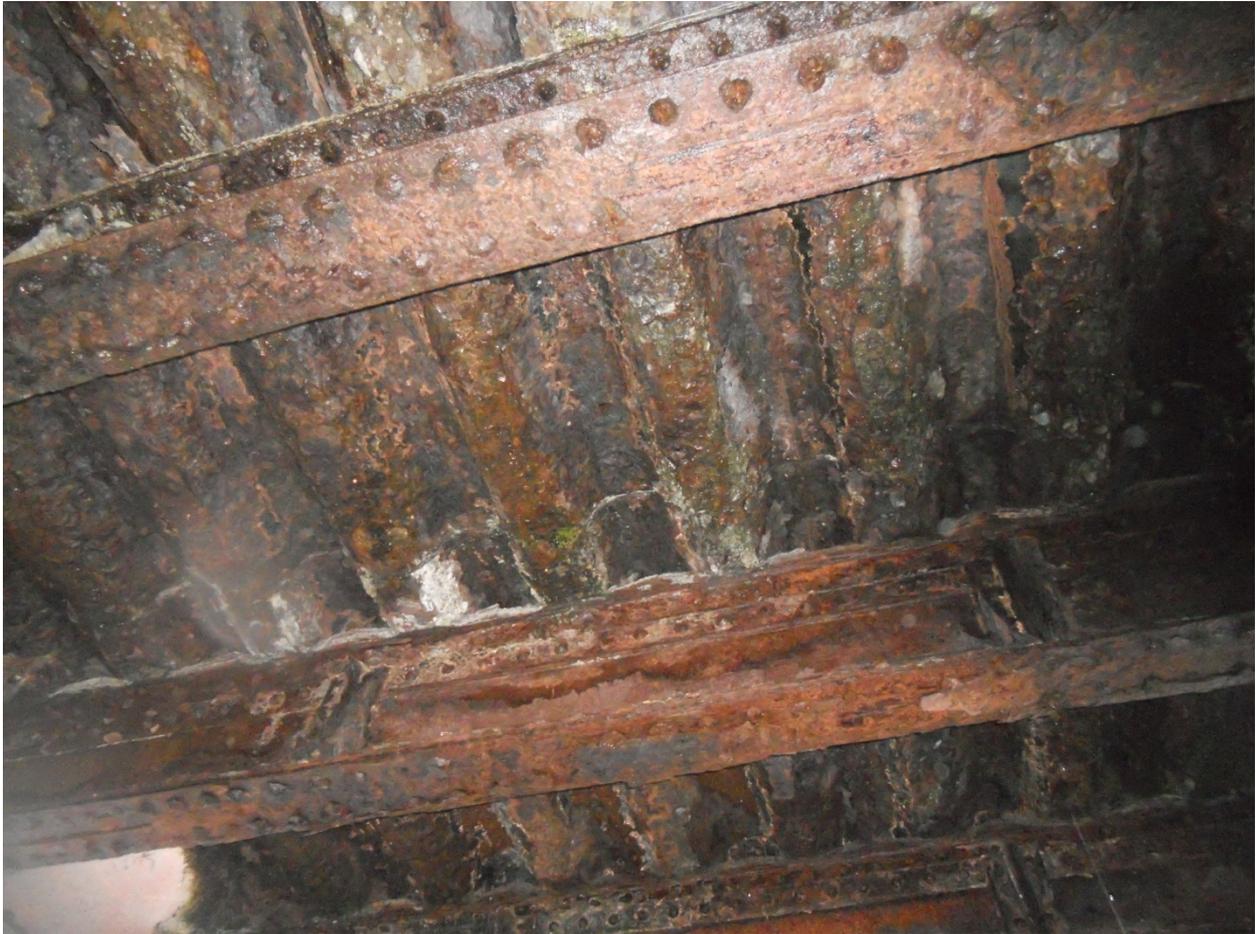
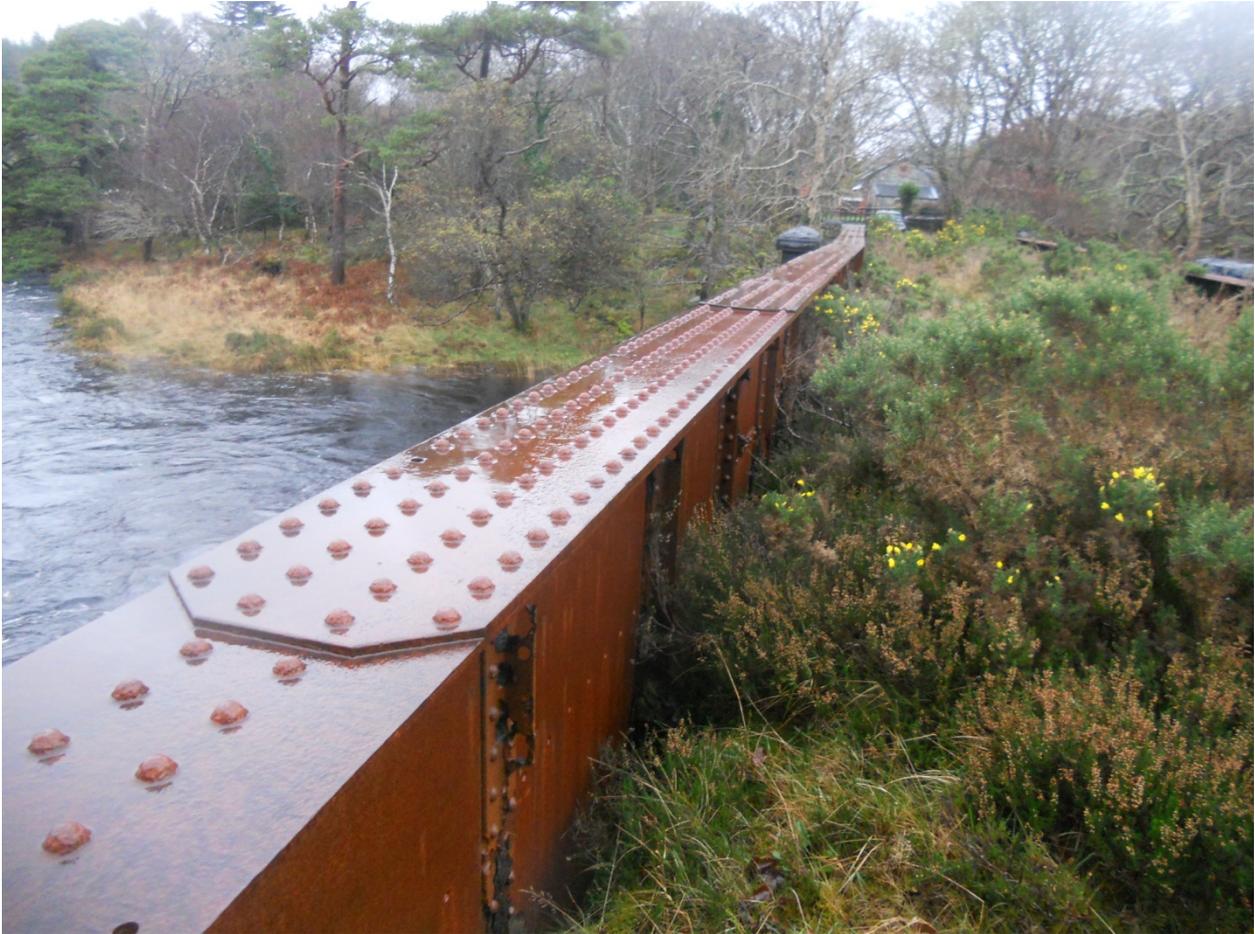
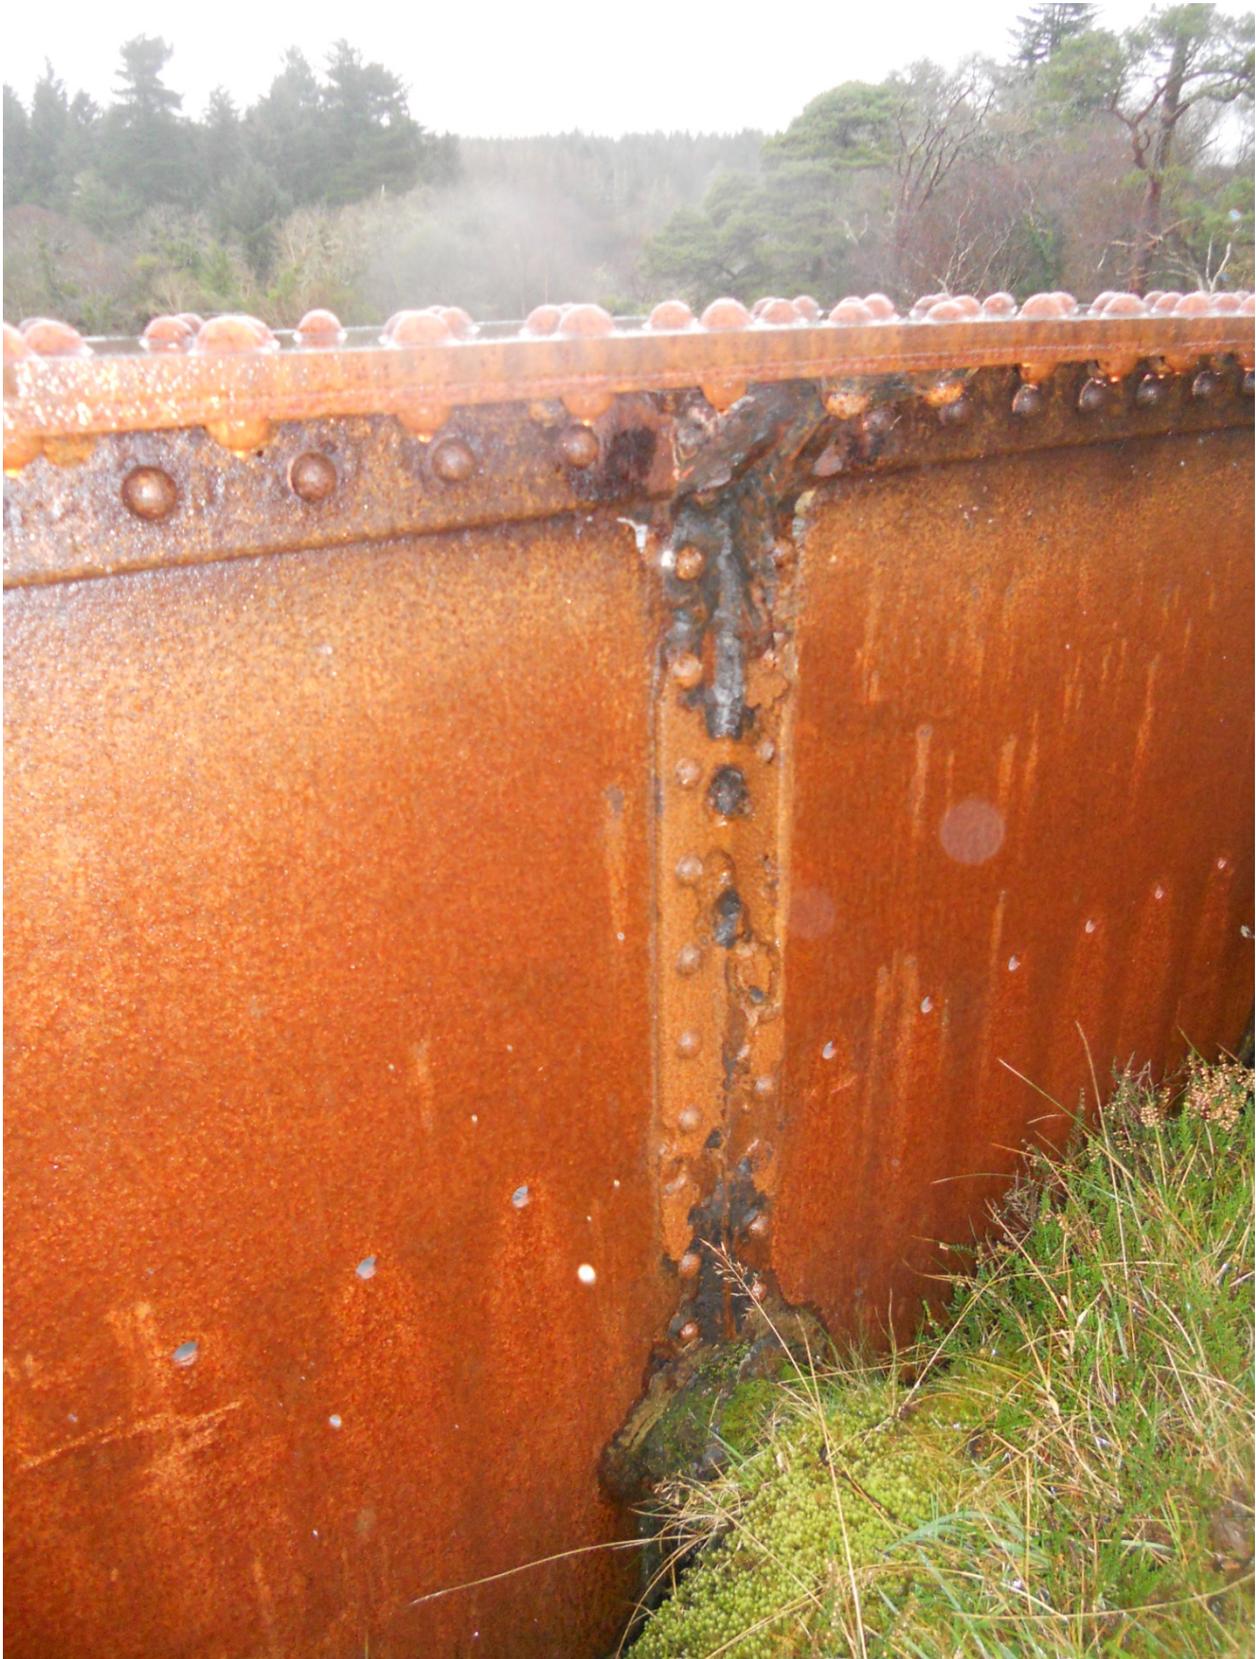
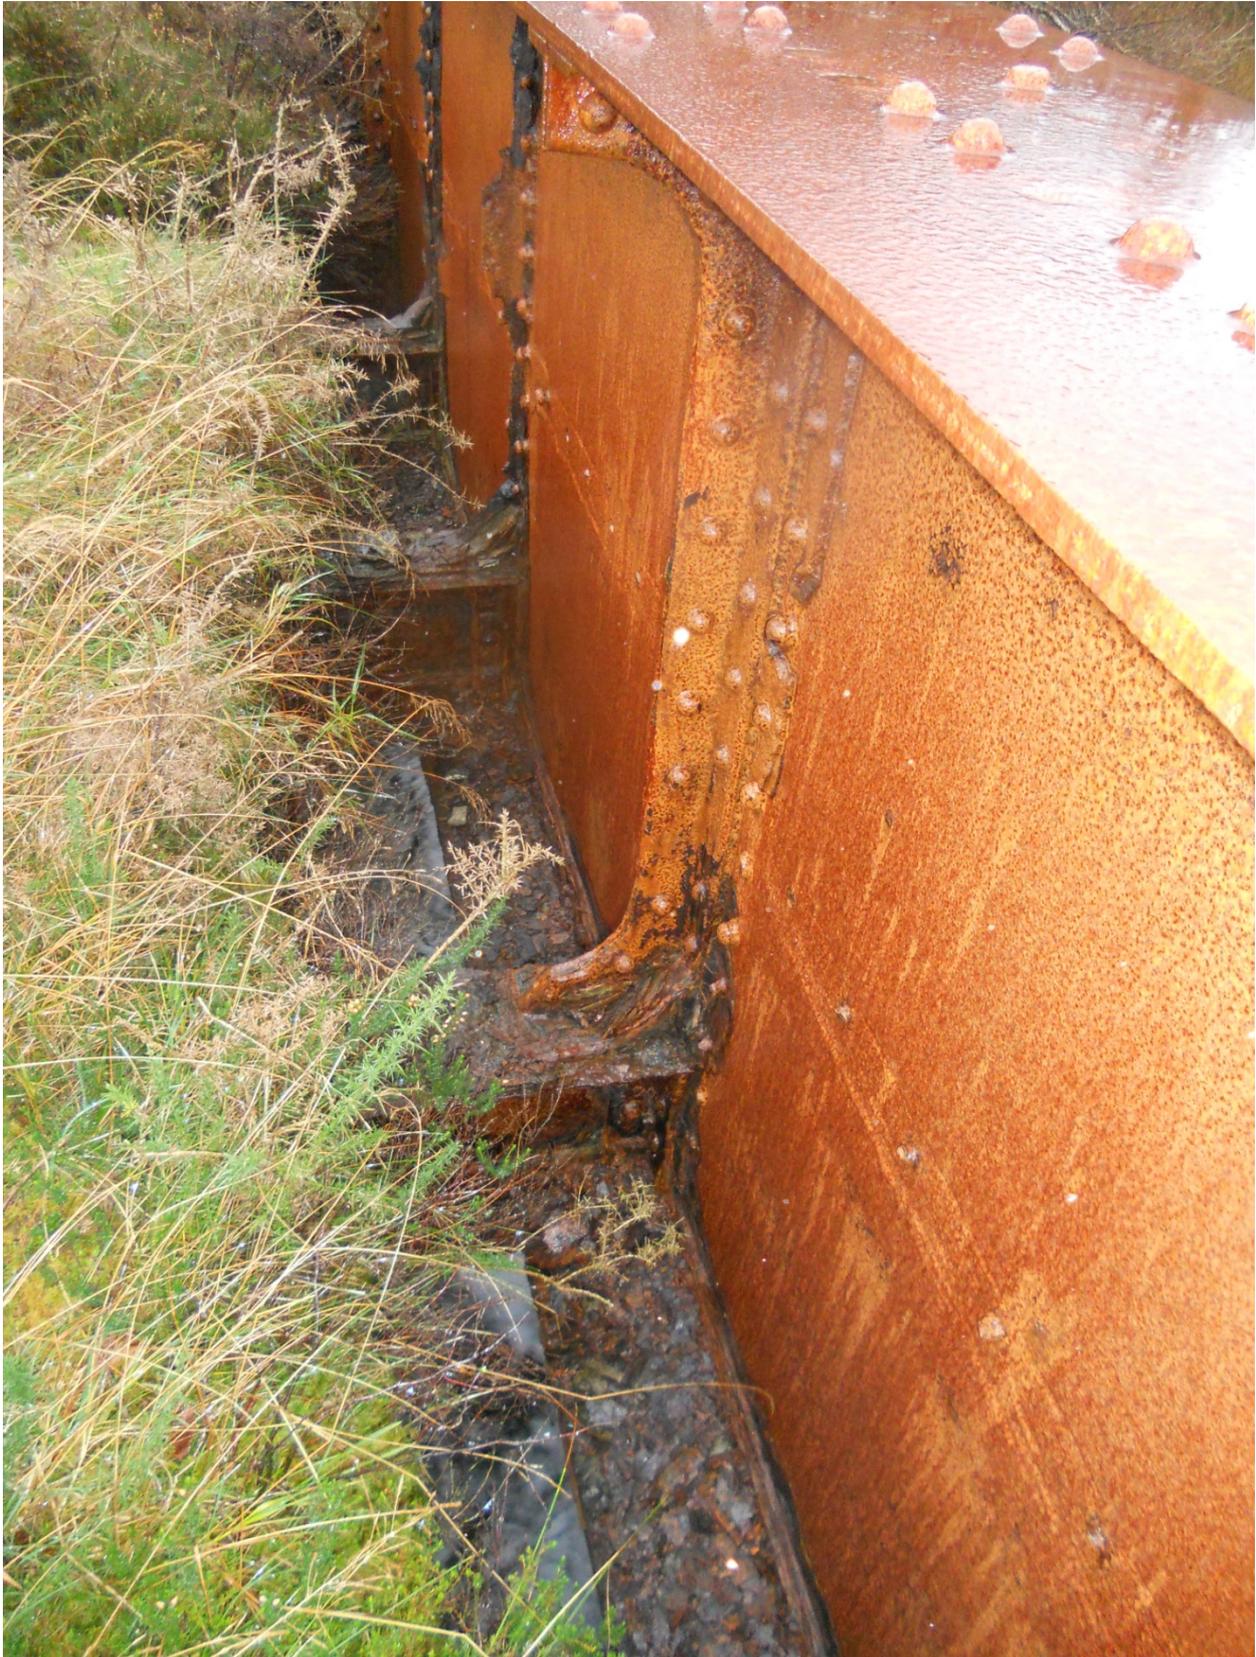
Photographs Cloonbeg Bridge

- 2.2.3 The main steel beams are plate girders with stiffeners at 1.25m c/c (i.e. at each transverse beam). There is significant corrosion on the girders themselves and many of the stiffeners have rusted away. Rivets are also missing at plate connections. We do not consider that the girders are suitable as structural members although they are to be retained for historical reasons.

- 2.2.4 The transfer beams are similarly corroded in some locations particularly at connections to the girders. The steel decking has corroded through in some locations. We believe that the new pedestrian bridge should not rely on either the transverse beams or the existing decking although they will be retained.

- 3.1 As noted earlier, the existing structure is not to be relied on. We propose to erect a new lightweight steel and timber structure over the existing. Details are shown in Sketch 02.

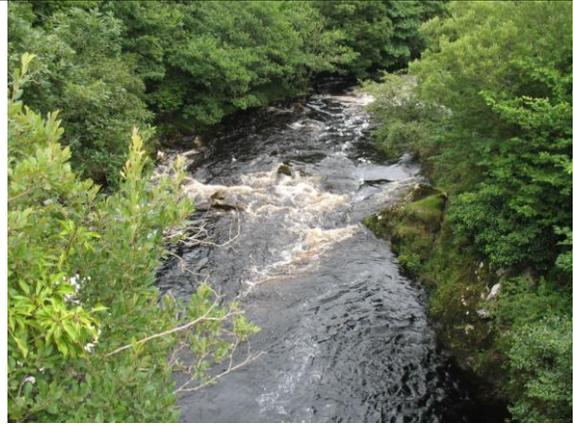
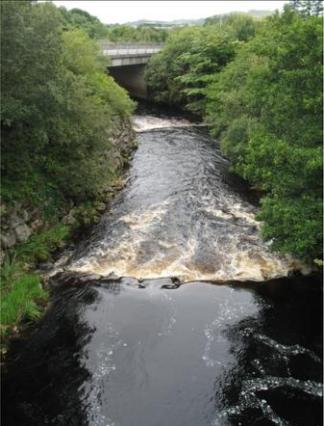
Site 1: Owenglin River, Near Clifden L67668 50508

Photo 1.1: View upstream of bridge	Photo 1.2: View downstream of bridge
This was a tumbling, peaty river with cascades and series of weirs. There was very little potential pearl mussel habitat.	There were no live mussels or dead shells found.

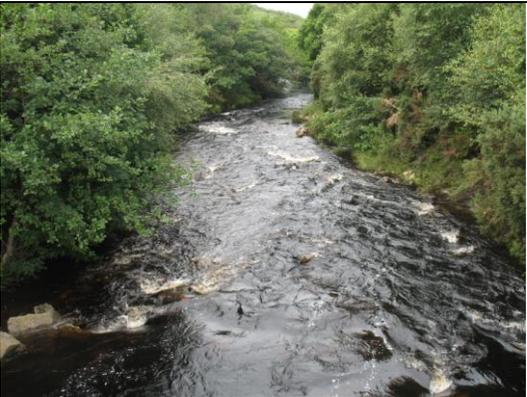
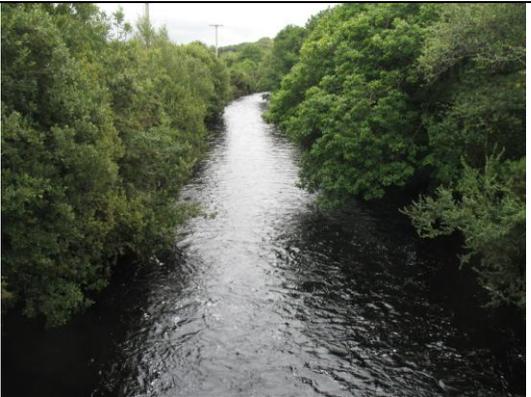
Site 2: Owenglin River, East of Clifden L68042 50368

Photo 2.1: View downstream of bridge	Photo 2.2: View upstream of bridge
This section had a bedrock dominated substrate. There was very little potential pearl mussel habitat.	There were no live mussels or dead shells found.

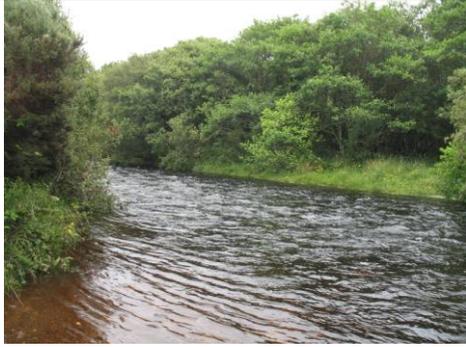
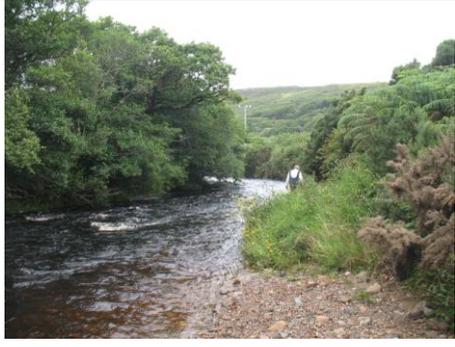
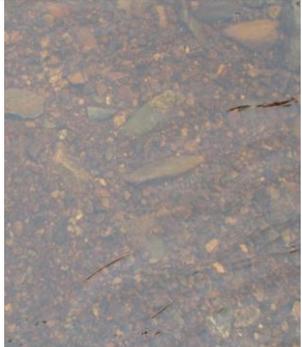
Site 3: Owenglin River, East of Clifden L68165 50293

<p>Photo 3.1: View upstream</p>	<p>Photo 3.2: View downstream</p>	<p>Photo 3.3: Substrate</p>
<p>This section had a riffle run with a good mix of substrate with cobble, gravel and sand (and very little silt). There was a good bankside vegetation structure with overhanging trees and gorse scrub. This was considered to be potential pearl mussel habitat, but none were seen. Note: there is a waste water treatment unit for the nearby hotel at the bend in the river.</p>		<p>There were no live mussels or dead shells found.</p>

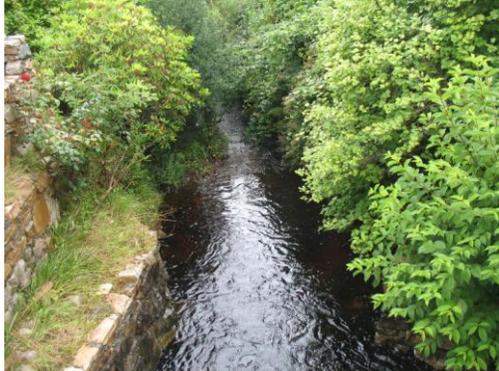
Site 4: Owenglin River, near Heritage Centre L73127 49386

<p>At this point the Owenglin is a shallow stream with pools and cascades, manipulated with revetted and ornamental banks. This is not suitable pearl mussel habitat.</p>

<p>There were no live mussels or dead shells found.</p>	<p>Photo 4.1: Downstream of centre</p>

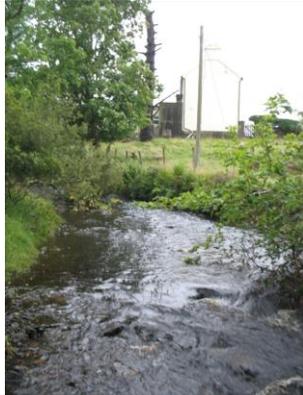
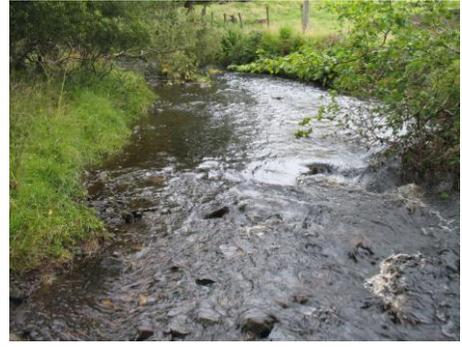
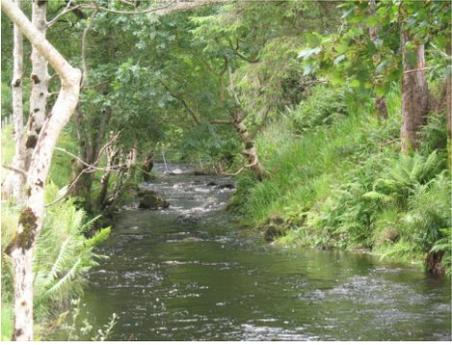
Site 7: Lettery Bridge at L77817 48240

<p>Photo 7.1: View downstream towards bridge</p>	<p>Photo 7.2: View upstream</p>	<p>Photo 7.3: further upstream</p>
<p>This stream had a relatively steep gradient and good riffle runs. Good black cobble and gravel substrate was found in places. There was unimproved grassland with flushes adjacent to the stream. This had good potential for pearl mussels but none were seen.</p>		<p>There were no live mussels or dead shells found.</p>

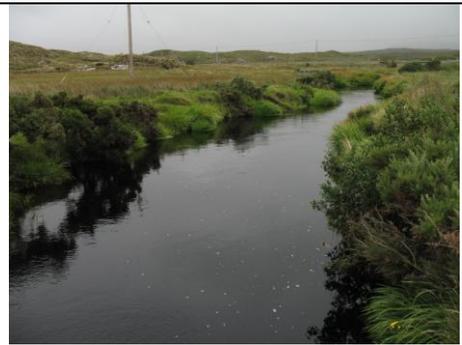
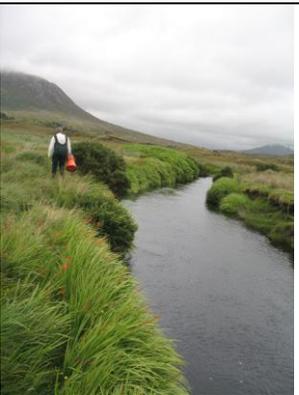
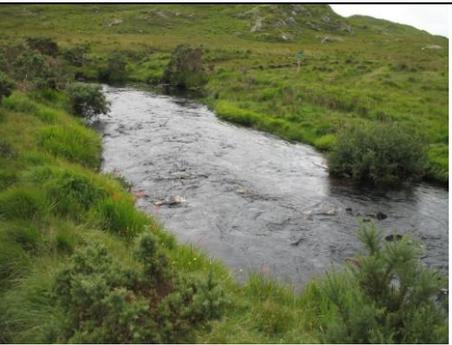
Site 8: Glencoaghan River at Glencoaghan Bridge (GC-N59-025.00), just above Ballynahinch Lake at L79681 47609

<p>Photo 8.1: Poned section</p>	<p>Photo 8.2: Poned section</p>	<p>Photo 8.3: Swift flowing section</p>
<p>Deep peaty ponded river upstream of the road, with riffle section downstream of the road, shallow with fontinalis-covered boulders. Scoured with small areas of gravels, and then becomes ponded again downstream.</p>		<p>There were no live mussels or dead shells found.</p>

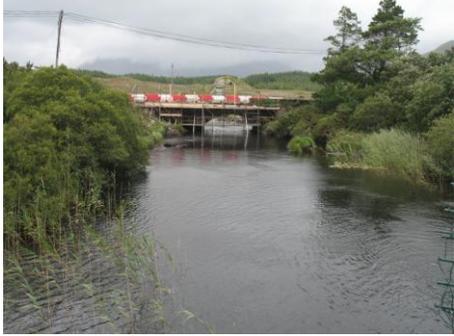
<p>Ponded and silty with <i>Phragmites</i> and <i>Nuphar</i> in places. Bridge works in progress (see Photo 11.1).</p> <p>No suitable mussel habitat.</p>

<p>There were no live mussels or dead shells found.</p>	<p>Photo 11.1: Downstream of bridge</p>

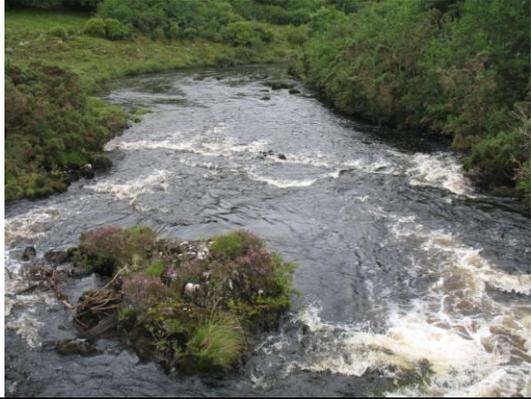
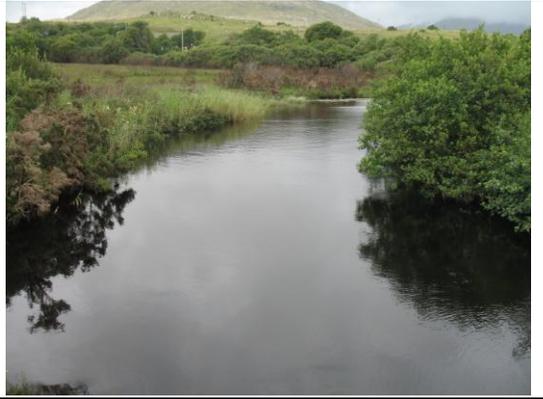
Site 12: Recess River at L86051 47168

<p>Photo 12.1: View upstream of bridge</p>	<p>Photo 12.2: View downstream of bridge</p>
<p>Riffle runs with suitable habitat interspersed with ponded areas with <i>Potamogeton</i>, <i>Nuphar</i>, <i>Phragmites</i>, <i>Menyanthes</i>, silted with filamentous algae</p>	<p>There were no live mussels or dead shells found.</p>

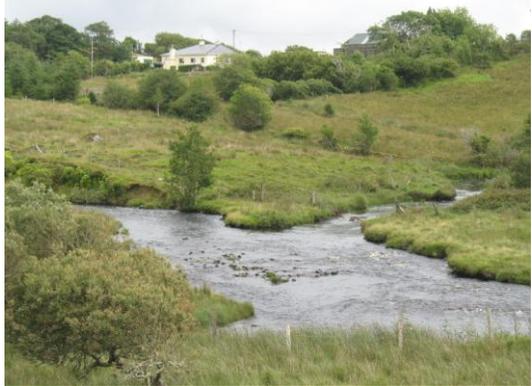
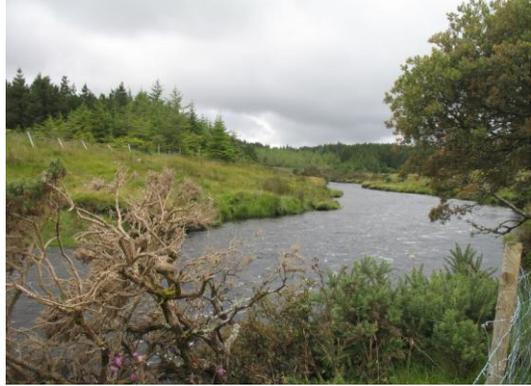
Site 13: Recess River just below confluence of Owentooey River and Caher River at L86939 47283

Freshwater pearl mussels : Present and Downstream

<p>Photo 13.1: View upstream of bridge</p>	<p>Photo 13.2: View downstream of bridge</p>
<p>Mixed habitats with areas of high water, strong flow, <i>Potamogeton</i> growth. Coniferous forestry on the south bank, rough sheep grazing on the north bank, areas of black cobble with stable sandy gravel.</p>	<p>A population of live pearl mussels was found in areas of suitable stable habitat.</p>

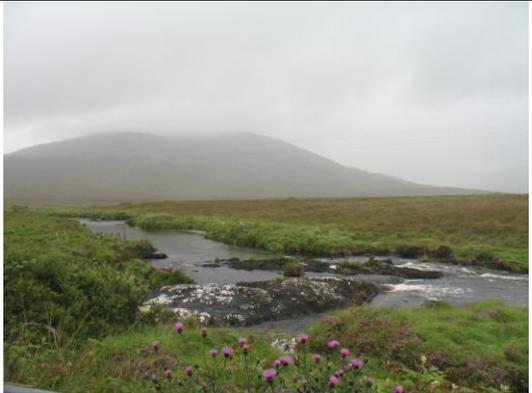
Site 14: Owentooey River at L87115 47589

<p>Good habitat of boulders, black cobble with stable sandy gravel. Good habitat upstream and downstream of the road.</p>

<p>A good population of live pearl mussels was found both upstream and downstream of the road.</p>	<p>Photo 14.1: Owentooey River</p>

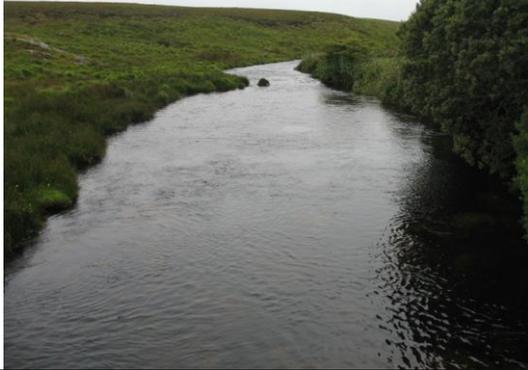
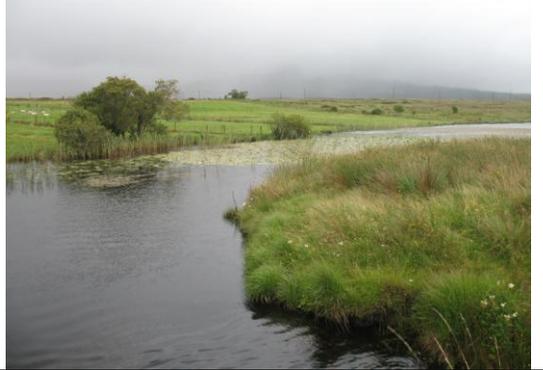
Site 15: Caher River at L87471 47034
Freshwater pearl mussels : Downstream

<p>Photo 15.1: View downstream of bridge</p>	<p>Photo 15.2: View upstream of bridge</p>
<p>Riffle runs with suitable pearl mussel habitat interspersed with ponded areas with <i>Potamogeton</i>, <i>Nuphar</i>, <i>Phragmites</i>, <i>Menyanthes</i>, silted with filamentous Algae.</p>	<p>There were no live mussels or dead shells found within the surveyed stretch, but live pearl mussels are found downstream.</p>

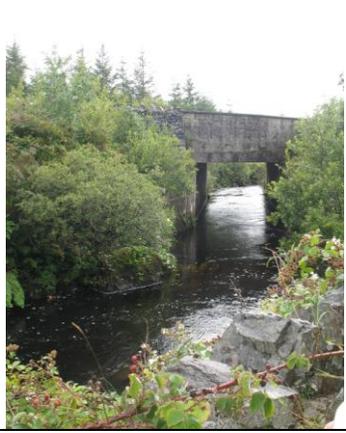
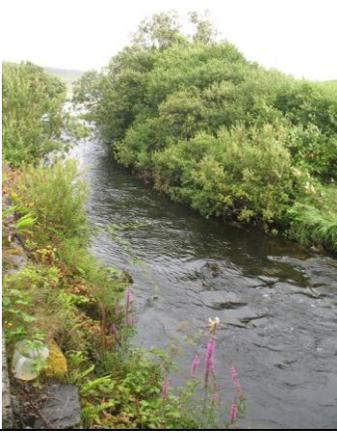
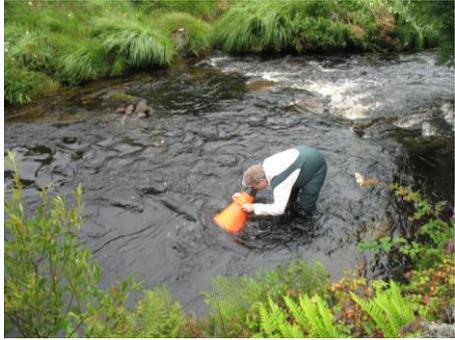
Site 16: Derrynreen Stream at L88633 46818
Freshwater pearl mussels : Present and Downstream

<p>Photo 16.1: View towards bridge</p>	<p>Photo 16.2: View upstream</p>	<p>Photo 16.3: Run with mussels</p>
<p>Generally good riffles with stable cobble & gravel substrate, some filamentous algae.</p>		<p>A good population of live pearl mussels was found downstream of the road.</p>

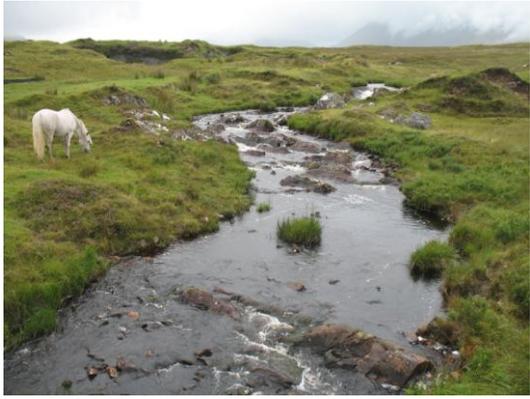
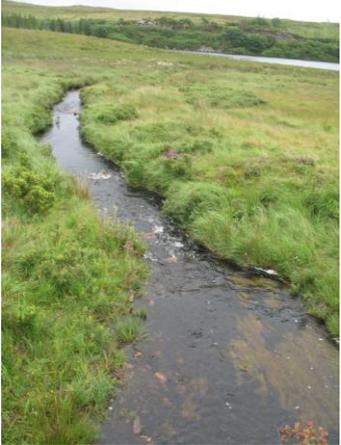
Site 17: Derrynreen Stream upstream of lake at L89189 46908
Freshwater pearl mussels : Present and Downstream

<p>Photo 17.1: Upstream of bridge</p>	<p>Photo 17.2: Downstream towards lake</p>
<p>Good riffle runs with stable cobble & gravel substrate.</p>	<p>A population of live pearl mussels was found upstream of the lake and downstream of the road.</p>

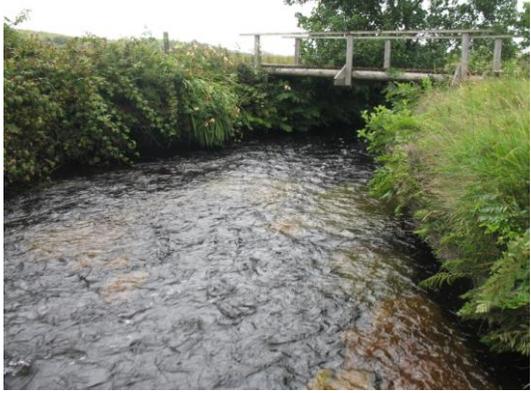
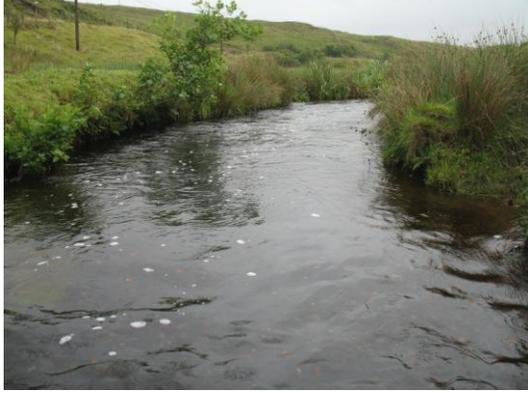
Site 18: Stream between side road and N59 at L89599 46650
Freshwater pearl mussels : Present and Downstream

<p>Photo 18.1: Downstream to bridge</p>	<p>Photo 18.2: Upstream</p>
<p>Good riffle runs with stable cobble & gravel substrate.</p>	<p>A population of live pearl mussels was found in riffles close to the footbridge.</p>

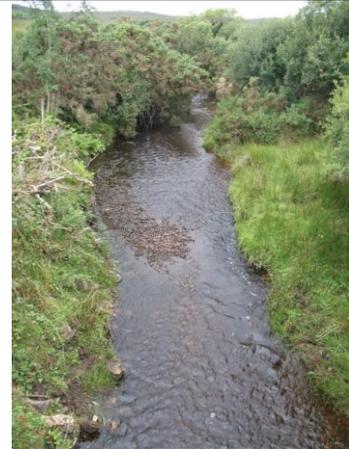
Photo 20.1: Bunowen River u/s of bridge

This was found to be a fast flowing shallow river with brightly coloured unstable cobbles that are unlikely to support a sustainable pearl mussel population.

There were no live mussels or dead shells found within the surveyed stretch, but live pearl mussels are found downstream in the Owenriff River.

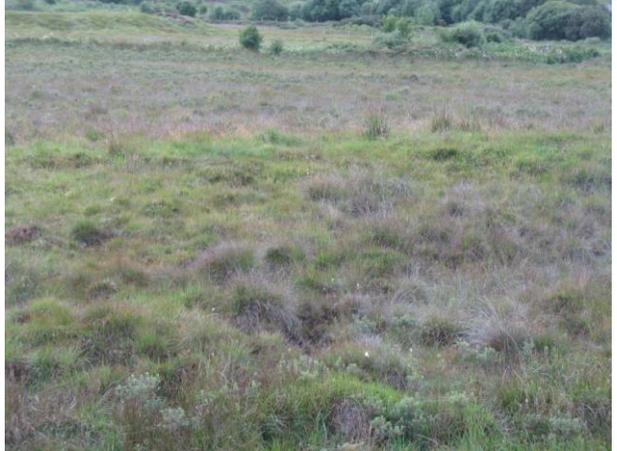
<p>This small tributary of the Owenriff system was found to be too steep and unstable for pearl mussels upstream, and ponded and boggy downstream. There was high quality acid flushing habitat in the surrounding land.</p>

<p>There were no live mussels or dead shells found within the surveyed stretch, but live pearl mussels are found downstream in the Owenriff River.</p>	<p>Photo 22.1 Small Owenriff catchment tributary</p>

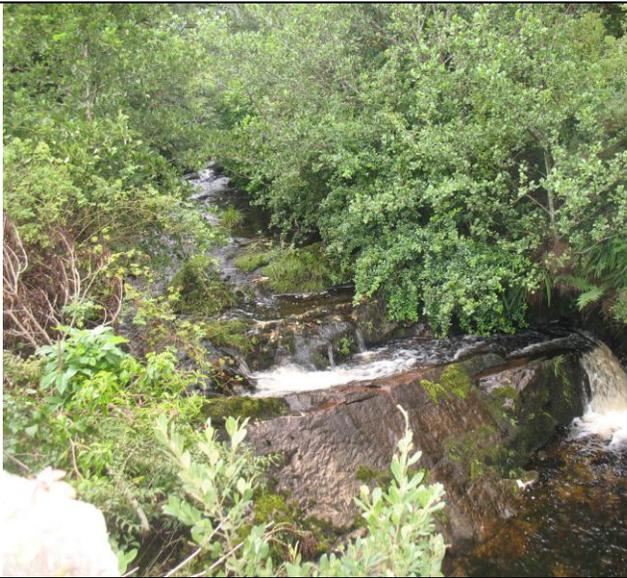
<p>Photo 23.1 Letterfore River</p>

<p>At Letterfore Bridge. This shallow river flows over a series of cascades followed by a steadier regime of shallow black pebble substrate. The river is unlikely to have enough water to support pearl mussels during drought periods.</p>

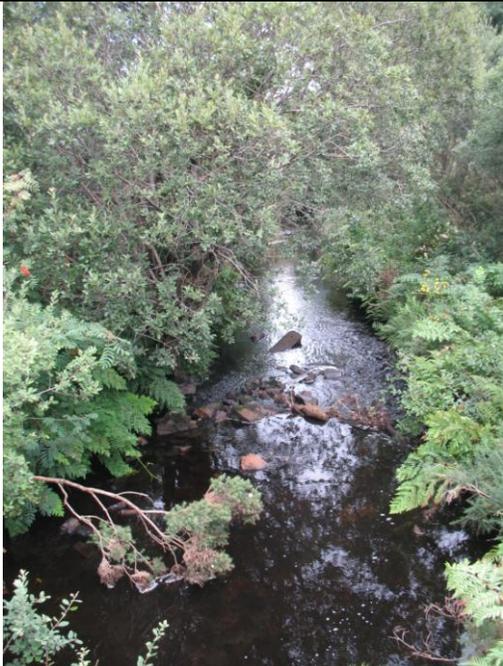
<p>This river was shallow and silted at the time of survey. The substrate was a combination of boulders, cobbles and gravel. The river is unlikely to have enough water to support pearl mussels during drought periods. Some filamentous algae was present.</p>

<p>There were no live mussels or dead shells found within the surveyed stretch.</p>	<p>Photo 24.1 Owenree River</p>

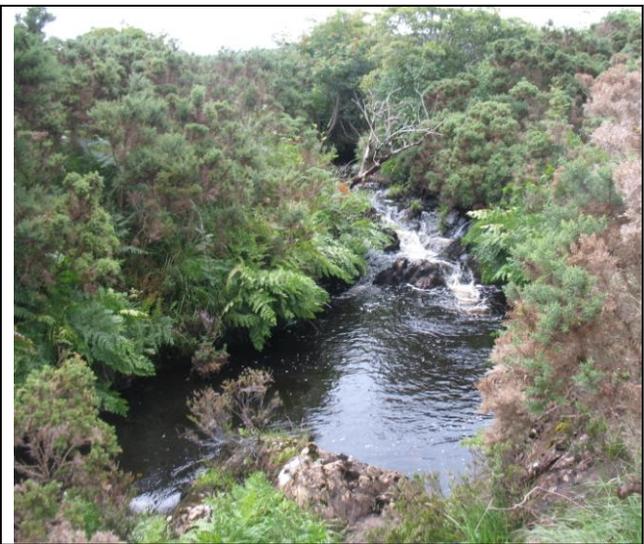
<p>This river flows down a rather steep gradient with some cascades, pools and dark substrate of boulders, cobbles and gravel. Some filamentous algae was present.</p>

<p>There were no live mussels or dead shells found within the surveyed stretch.</p>	<p>Photo 25.1 Owenwee River</p>

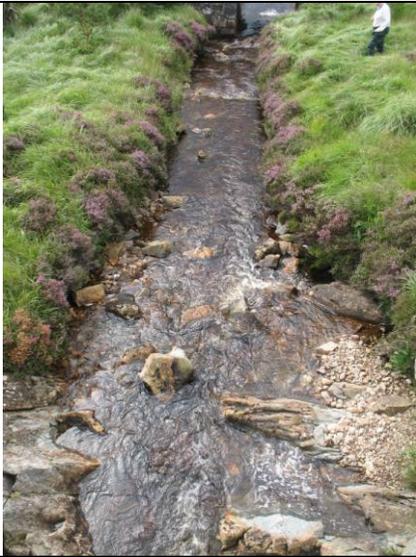
<p>This shallow river flows into Lough Oorid. It is shallow and laminar downstream of the road, and is very scoured with bright brown sandy substrate with some cobble and pebble. There are also <i>Schoenus nigricans</i> flushes downstream of the road with a good mix of brown mosses, <i>Carex viridula</i> and <i>Pinguicula vulgaris</i>.</p>

<p>There were no live mussels or dead shells found within the surveyed stretch, however <i>Margaritifera</i> is present downstream.</p>	<p>Photo 27.1 Owenanookera River</p>

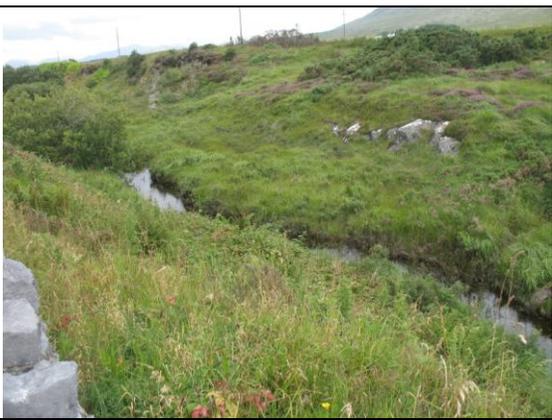
<p>This shallow river of 1.5m wide is ponded with emergent weed. This is not suitable pearl mussel habitat.</p>

<p>There were no live mussels or dead shells found within the surveyed stretch, however <i>Margaritifera</i> is present downstream.</p>	<p>Photo 28.1 Ponded stream</p>

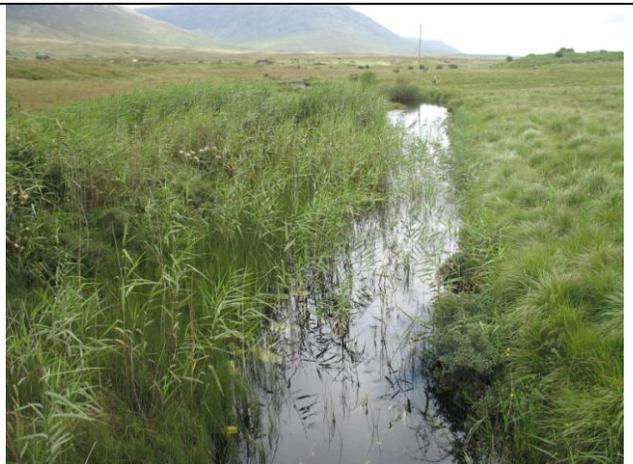
Photo 30.1 Ponded stream upstream

This river is deep and ponded with emergent *Phragmites* reeds and aquatic growths of *Nuphar*. This is currently not suitable pearl mussel habitat, although a record of live pearl mussels has been found in the vicinity in the past (Ross, 1988). The river may have been deepened or otherwise altered since that record in 1983.

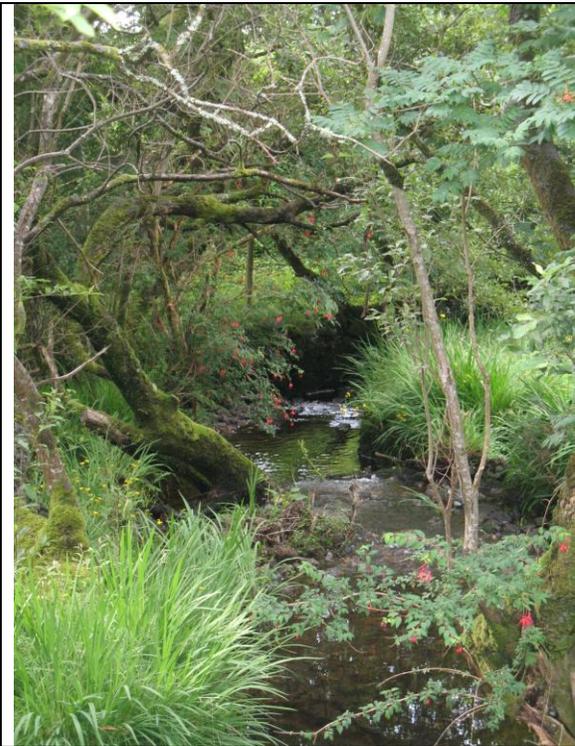
Photo 31.1 Compacted stream

This river is shallow with low flows at the time of the survey. The substrate was even and highly compacted.

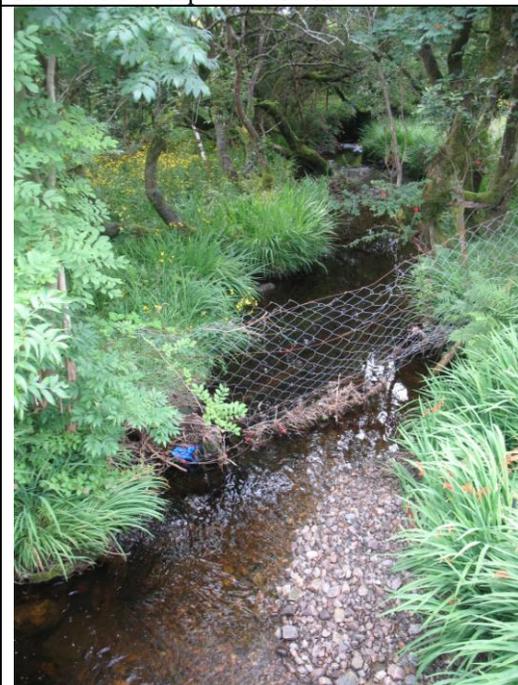
Photo 31.2 Shallow, compacted substrate

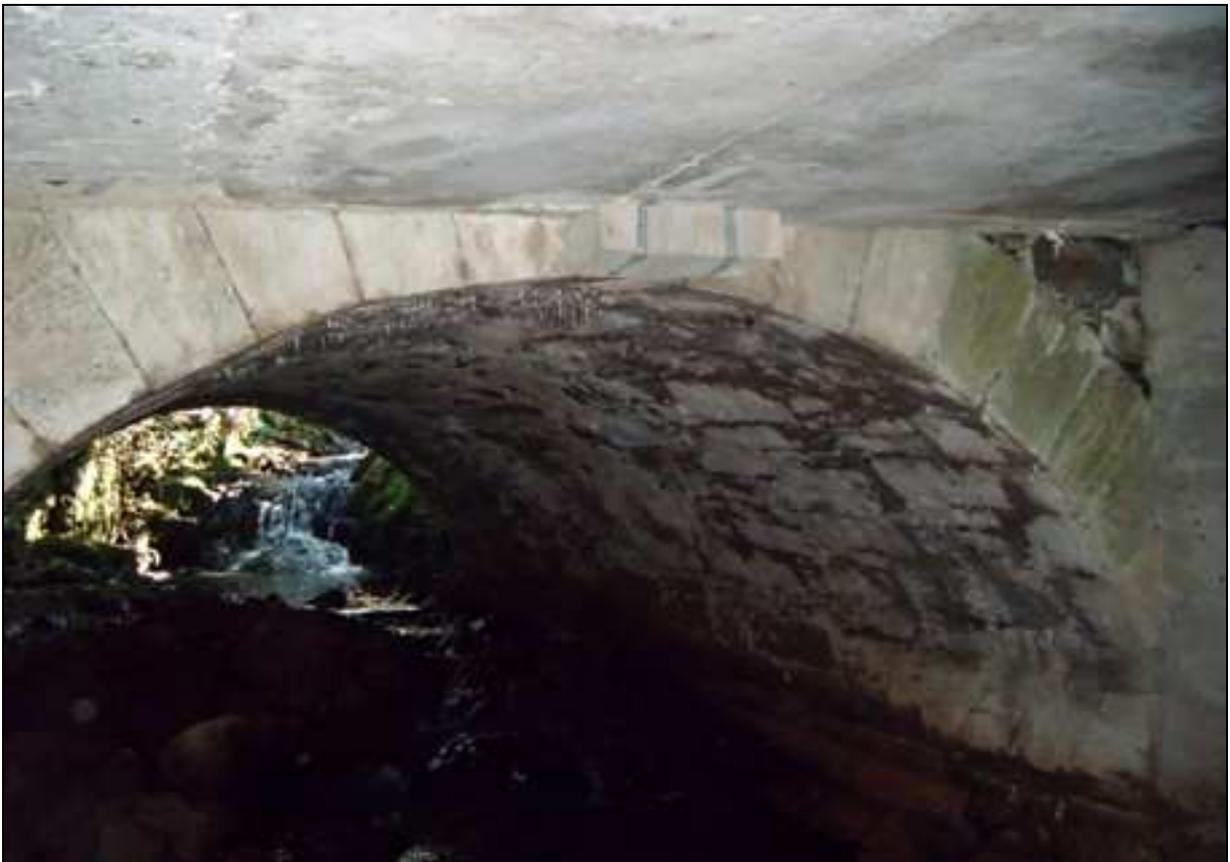
Plate 5: One of two bat tubes installed on bridge GC-N59-022-00 at Chainage 231200
